Autonomous systems thermographic NDT of composite structures

S. Deane^{1*}, N.P. Avdelidis^{1,2}, C. Ibarra-Castanedo², H. Yazdani Nezhad¹, A. Williamson³,
H. Zhang², V. Tzitzilonis¹, X.P.V. Maldague², A. Tsourdos¹

¹ School of Aerospace, Transport and Manufacturing, Cranfield University, United Kingdom.

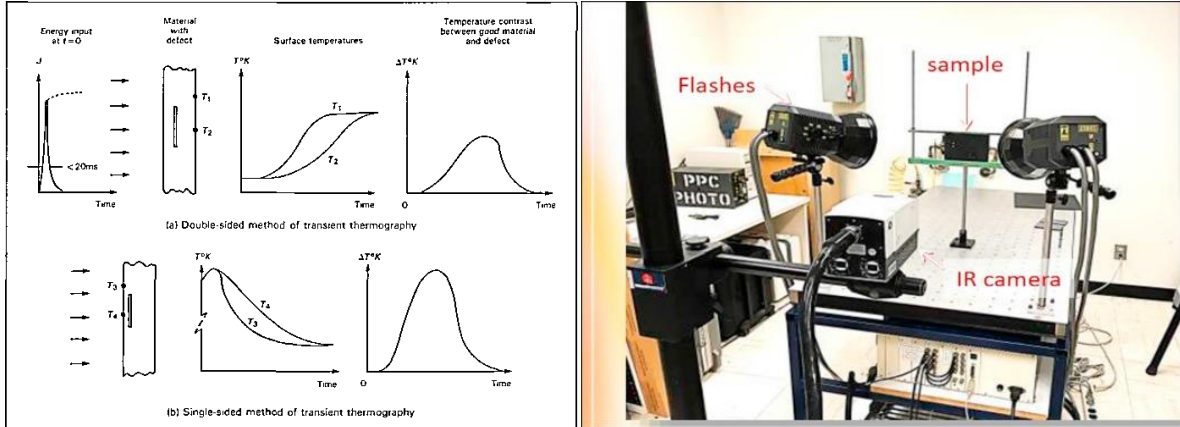
FIGURE 1 (LEFT): THE IMAGE REPRESENTS TRANSIENT THERMOGRAPHY AND HOW THE TEMPERATURE DIFFERS WHEN THERE IS A DEFECT PRESENT. (A) THE TRANSMISSIVE MODE (DOUBLE-SIDED) AND (B) THE REFLECTIVE METHOD (SINGLE-SIDED) [2]. FIGURE 2 (RIGHT): EXPERIMENTAL SET UP [5].

The surface of the specimens were positioned parallel to the camera lens as depicted in Fig. 2. The data was acquired for 40 s with a 1.5 ms integration time, that includes 10 frames before the flashes, plus 1990 frames during cooling a total of 2000 frames were recorded. The software used to acquire the data was RDac from FLIR. For signal processing MATLAB and Ir_view from Visioimage inc were employed. Two advanced processing techniques were used; PCT (principal component thermography) and PPT (pulsed phase thermography) [5].

The figures below (Figures 3-8) are all the processed results. A reflection test means that the camera and the excitation source are on the same side (as seen in Figure 4). Generally, reflection is more suited to detect defects closer to heated surface. PPT (pulsed phase thermography) was one of the methods used, with the acquired temperature data it varies with time and is transferred to phase data, which varies with frequency, the frequencies which show adequate data are below each image in hertz. PCT (principal component thermography) was the other, method used, the data is re-ordered by variance, this method finds both time series and spatial patterns, most of the variability is contained in the first component: EOF1 (empirical orthogonal function). Usually, EOF1 shows thermal variations related to surface heating. Later EOFs are typically related to surface and subsurface damage. Comparing both techniques, for this specific data set in figure 5 it seems that the PCT technique displays the damage clearer [5].

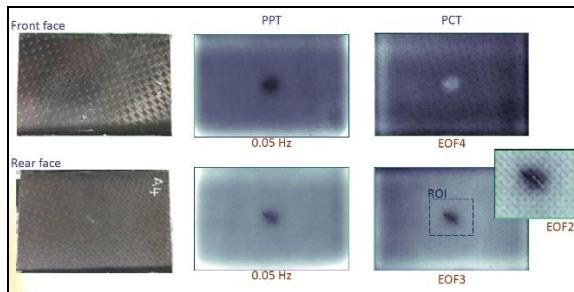
Figure 5: Sample A4 (15 J). Transmission is where the one side of the composite is excited, and the other side is observed by the camera and captures the data [5].

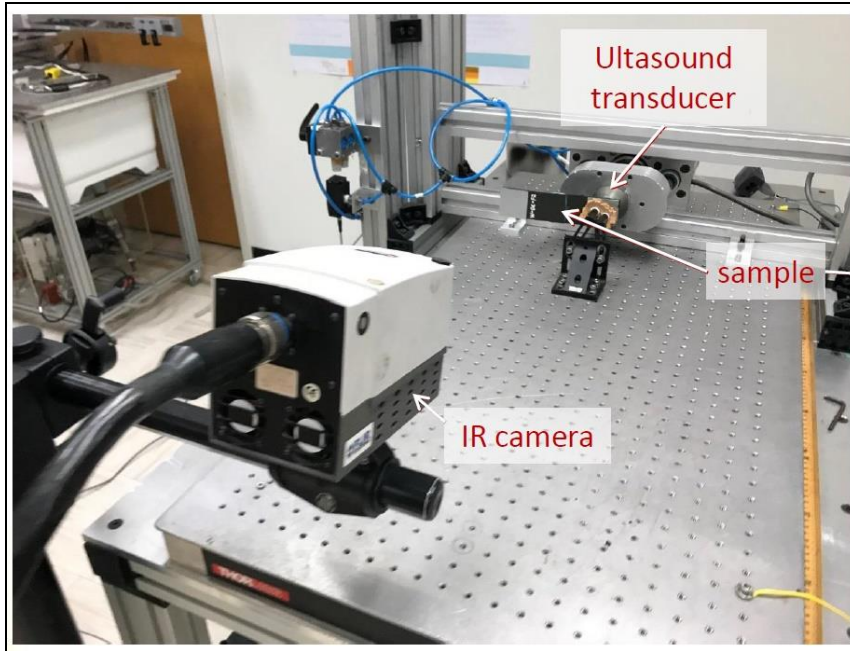
Figure 9: Experimental set up [5]

The data processing is usually easier to manage when using VT, this is since the source of the heat is the damage itself [16]. The IR camera used to capture the data, is the same as used in the PT experiment explained in 2.2. Figure 9 displays the VT testing equipment and the experimental set up, the transducer used is a 20 kHz ultrasound generator (BRANSON 2000). The experiment will consist of inspecting three different specimens to search for defects but more specifically concentrating on kissing bond defects [5].

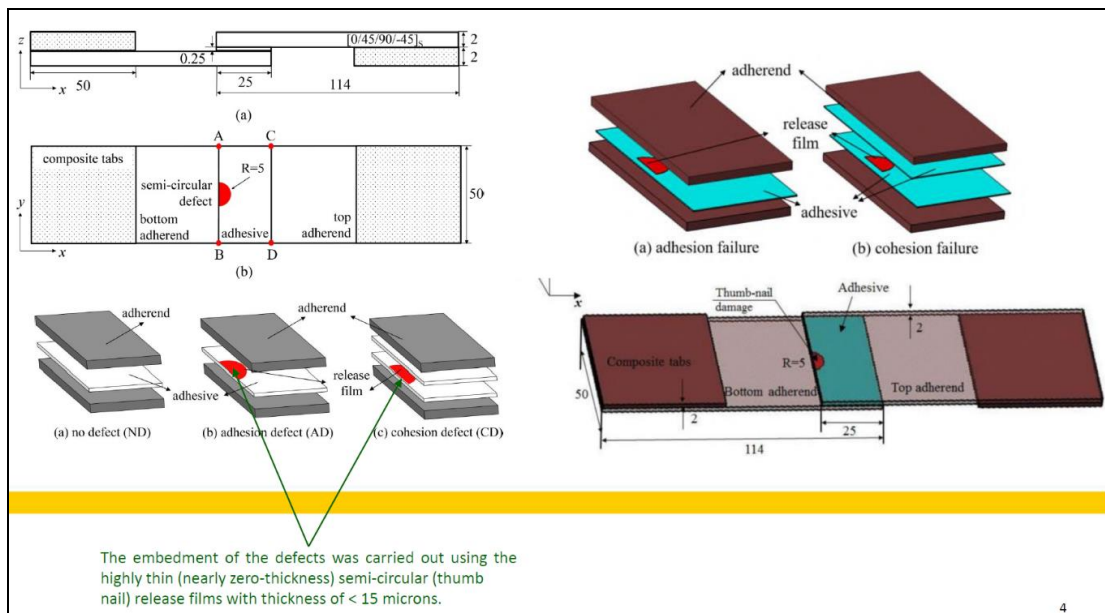
Figure 10: Artificial defects release film kissing bond [17].

The three inspected specimens are all composite material with artificial defects (see fig.10,11,12,13)

- **Specimen N-D-F4P** is composed of one layer of adhesive sandwiched by two layers of adherent (carbon fiber) and contains no defect, it was purposely used for reference only.
- **Specimen W-DA-F4** is similar to N-D-F4P but with an adhesive film release semi-circular ("thumb nail") shape defect, simulating a kissing bond defect.

- **Specimen W-DC-F2** is similar to W-DA-F4 but with an additional adhesive film on top of the one with the simulated defect.

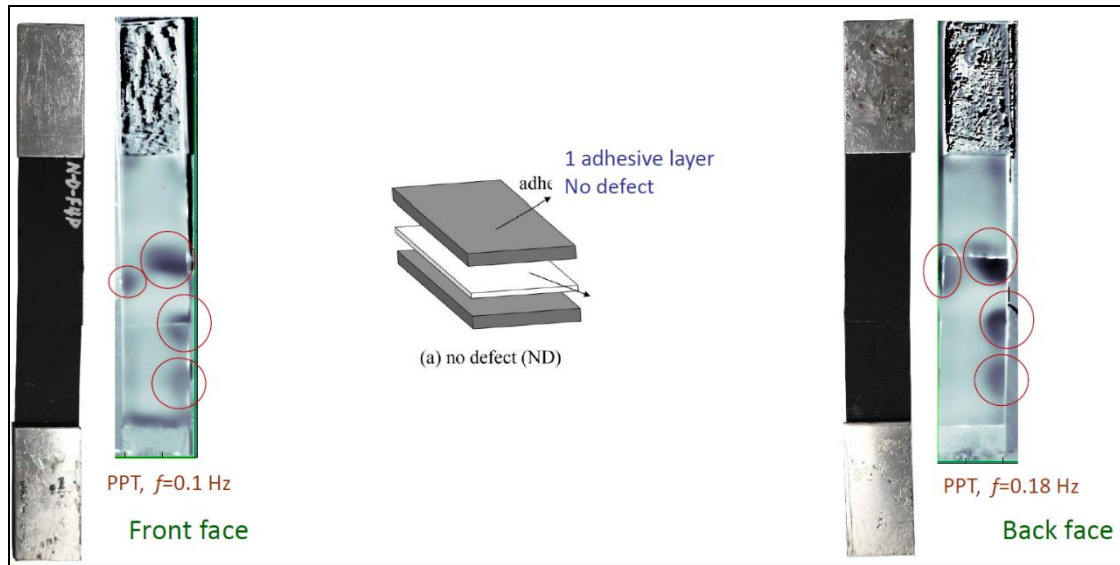
Sample N-D-F4P: Vibrothermography:

There was no kissing bond defect detected in specimen N-D-F4P (as expected) however, delamination-like defects were identified. The vibrothermography results in the two previous samples are promising for the detection of kissing bond

Figure 13: The postprocessed results from the vibrothermographic inspection on sample N-D-F4P [5].
